# Manhole Inspection Summary

Manhole # S69W\_\_002MH

**Location** Address: **1901 Portal St.**

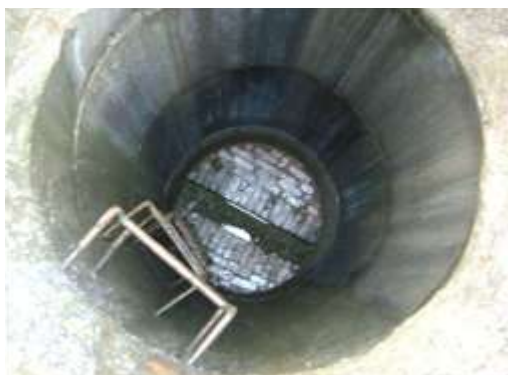
Defect 1

Condition: ☐ Sound ☐ Cracked ☐ Root Intrusion ☒ **Loose Brick** ☒ **Deteriorated**

Infiltration: ☐ None ☐ Joint ☐ Cracks ☒ **Mortar** ☐ Roots ☐ Wall

Infiltration from chimney to bottom of barrel

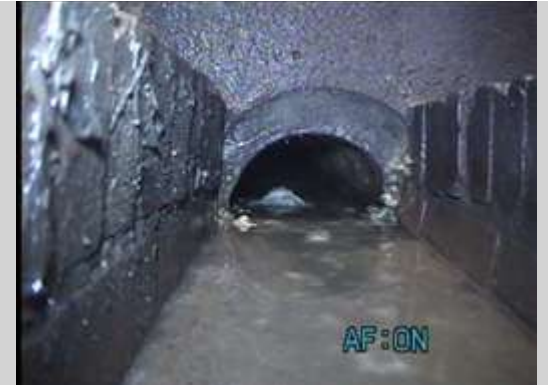
12 O'Clock Outflow

8 in. Circular Gravity Sewer  
Pipe Out @ 12 O'Clock

Pipe Height: **8.4** (in.) Rod and Bar (Angled)  
Pipe Material: **Clay** ☐ Pipe Lined  
Invert Depth: **13.58** (ft.) Flow Characteristics: **Slow**  
Deposits: ☐ None ☐ Mud ☐ Sludge ☒ **Debris** ☐ Grease  
Silt Depth: **3** (in.) Deposits Extent: **Medium**  
Infiltration: **None** Pipe Seal Cond: **Sound**

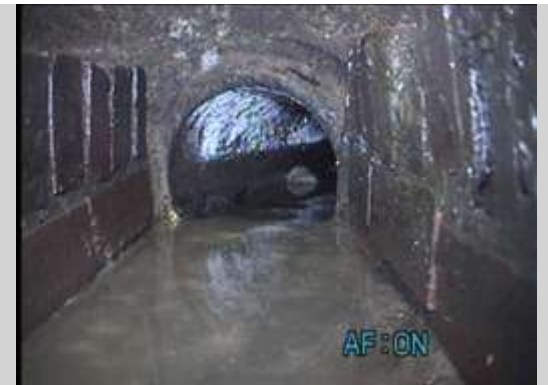
6 O'Clock Inflow

8 in. Circular Gravity Sewer  
Pipe In @ 6 O'Clock

Pipe Height: **8.4** (in.) Rod and Bar (Angled)  
Pipe Material: **Clay** ☐ Pipe Lined  
Invert Depth: **13.33** (ft.) Flow Characteristics: **Slow**  
Deposits: ☐ None ☐ Mud ☐ Sludge ☒ **Debris** ☐ Grease  
Silt Depth: **1** (in.) Deposits Extent: **Light**  
Infiltration: **None** Pipe Seal Cond: **Sound**
